Manhole Inspection Summary

Manhole # S43EE_050MH

Insp Date: **3/10/08 12:31 PM**

Location Address: **1800 CHASE ST**

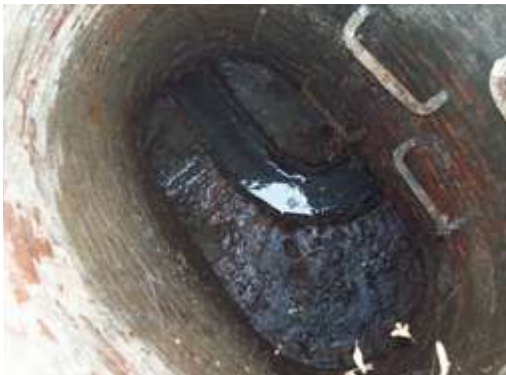
Defect 2

Steps Count: **4** Missing: **1** ☒ **Corroded**

corroded steps, missing 1

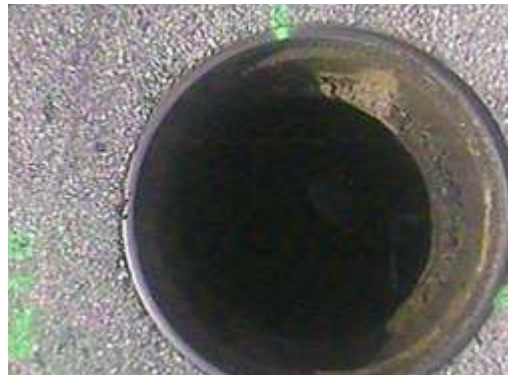
Defect 1

Frame Offset: **1** (in.) Condition: ☒ Sound ☐ Cracked ☐ Leaks

frame offset

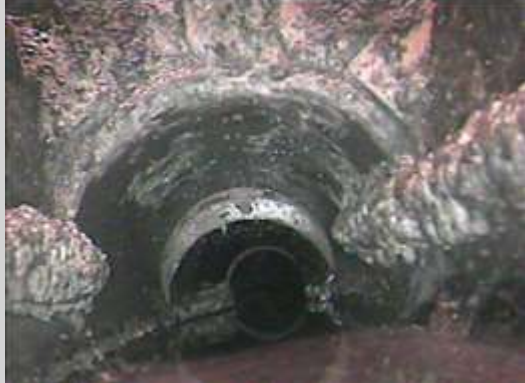
12 O'Clock Outflow

frame offset

Pipe Height: (in.) Direct
Pipe Material: **Clay** ☐ Pipe Lined
Invert Depth: **9.10** (ft.) Flow Characteristics: **Slow**
Deposits: ☐ None ☐ Mud ☒ Sludge ☒ Debris ☐ Grease
Silt Depth: **4** (in.) Deposits Extent: **Medium**
Infiltration: **None** Pipe Seal Cond: **Sound**

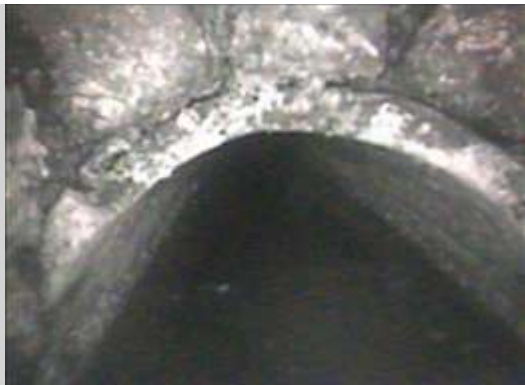
3 O'Clock Inflow

frame offset

Pipe Height: (in.) Direct
Pipe Material: **Clay** ☐ Pipe Lined
Invert Depth: **9.05** (ft.) Flow Characteristics: **Slow**
Deposits: ☒ None ☐ Mud ☐ Sludge ☐ Debris ☐ Grease
Silt Depth: (in.) Deposits Extent:
Infiltration: **None** Pipe Seal Cond: **Sound**
